FUTURE REGENERATION PROCESSES FOR HIGH PRESSURE TURBINE BLADES

M. Nicolaus¹, B. Rottwinkel², K. Möhwald¹, C. Nölke², S. Kaierle², H. J. Maier¹,
V. Wesling²,

Abstract

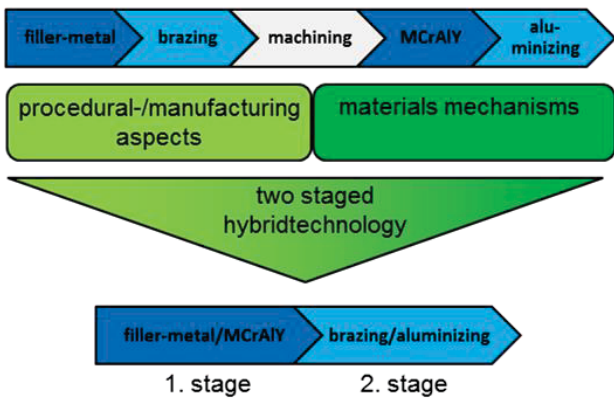
FIGURE 1. Process chain (present and future) for repair brazing turbine blades

In earlier works [5, 7] the development of a two staged hybridtechnology to reduce the process chain of repair brazing turbine blades is described (figure 1).

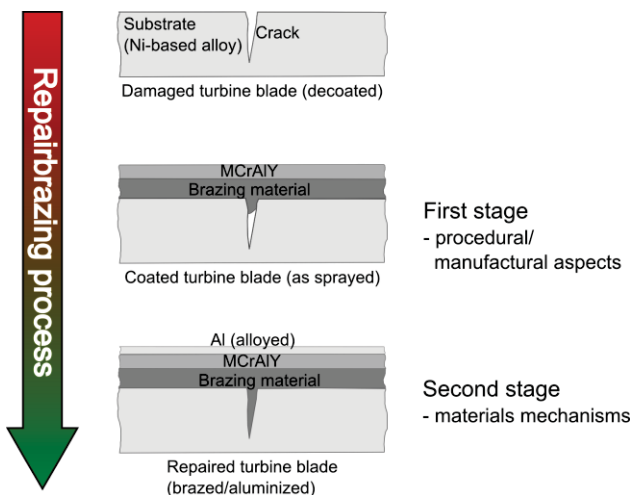
In this technology the brazing material and the hot gas corrosion protective coating are applied in a mutual process by means of thermal spraying which is the first stage of this hybridtechnology. The second stage of this process integrates the brazing section (transient-liquid-phase-bonding-process) into the CVD aluminizing. The principle of this hybridtechnology is shown in figure 2.

FIGURE 2. Principle of repair brazing/aluminizing turbine blades

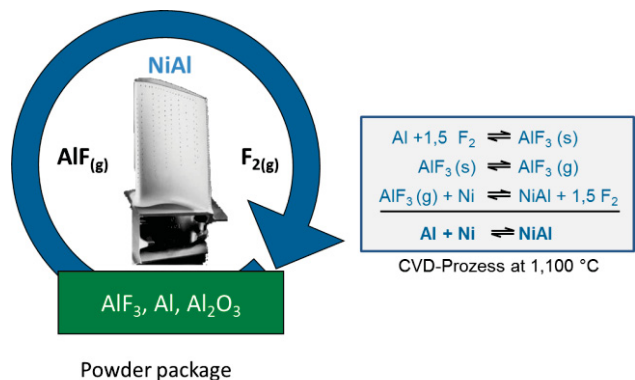
For the aluminizing process a powder package is used containing 3 wt.% aluminium fluoride (AlF₃), 1 wt.% Aluminium (Al) and 96 wt.% Alumina (Al₂O₃). The principle of the aluminizing is shown in figure 3. The specimens were embedded into the powder package and the combined brazing/aluminizing process was carried out in a high vacuum furnace. To evaluate the coatings and the results of the brazing/aluminizing process metallographic cross-sections and optical-microscopic pictures were prepared.

FIGURE 3. Principle of aluminizing

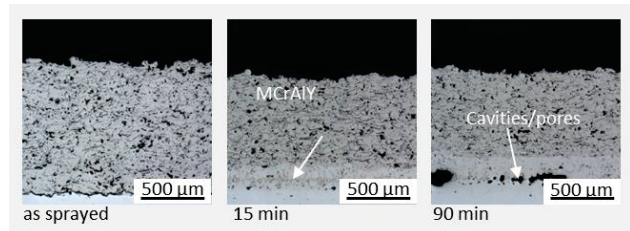
In previous works [7, 9] could be shown that it is possible to apply the brazing material and the hot gas corrosion protective coating in a common process by means of thermal spraying. The applied brazing material shows a good crack infiltration capacity. But the longer the brazing material is in the liquid state the more cavities or pores in the brazing material are formed (figure 5).

FIGURE 5. Common coating and heat treatment of brazing material/MCrAlY (APS)

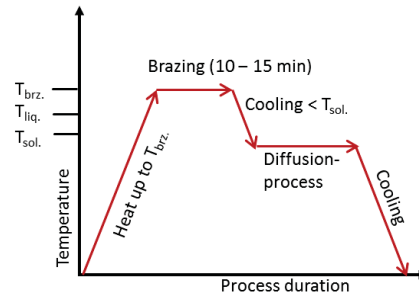
To that effect the temperature-time regime is adjusted to minimize the pores (figure 6).

FIGURE 6. Temperature-time regime of the brazing/aluminizing process to reduce pores or cavities

The prepared specimens were heated up in the aluminizing powder package to the brazing temperature and the brazing section lasts 10 to 15 minutes. The temperature then was lowered just under the solidus of the brazing material. At this point the partial pressure of the aluminium is still high enough to alloy with the MCrAlY coating. Figure 7 depicts the result of the brazing/aluminizing process. Compared to the heat treatment of the coating system shown in figure 5 the pores in the brazing material were reduced. The cross-section on the left in figure 7, shows the brazing/aluminizing process with a total duration of 735 minutes (15 minutes brazing time at brazing temperature and 12 hours below solidus of the brazing material) and only some pores can be observed. On the right side two huge pores can be found although the process duration was just 135 minutes (15 minutes brazing, 120 minutes below solidus). In all mentioned processes one can also find the nickel-rich phases (bright regions) and brittle phases (dark regions) in the brazing material.

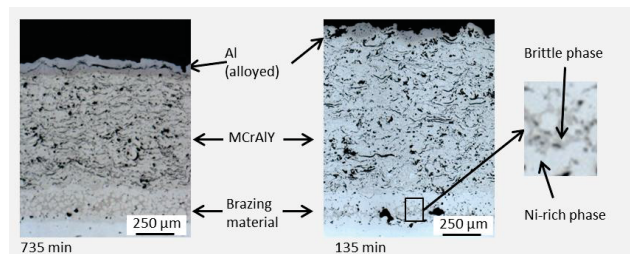
FIGURE 7. Brazing/aluminizing process

The reason that pores still occur could be small local differences in the composition of the brazing material which can lead to early fused spots. To equalize or

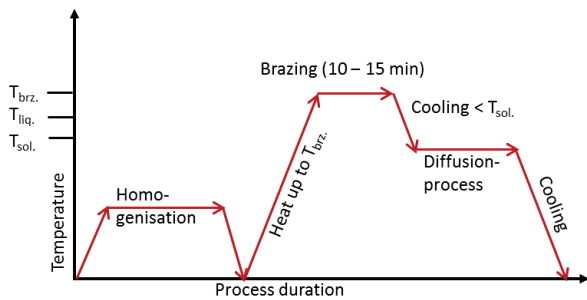
minimize these composition differences the previous temperature-time regime is enhanced by a homogenisation annealing step (figure 8).

FIGURE 8. Enhanced temperature-time-regime

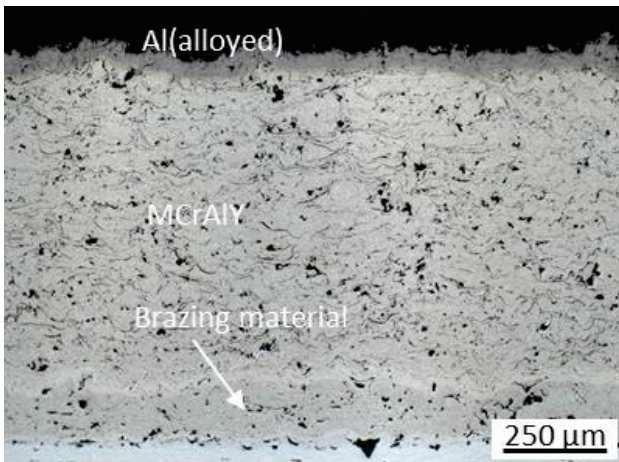
Figure 9 shows the cross-section of the coating. The duration of the homogenisation was 24 hours. The following brazing/aluminizing process lasts 735 minutes so that the heat-treatment had a totally duration of 36.25 hours.

FIGURE 9. Brazing/aluminizing process with homogenisation step

The results show that a formation of pores is unavoidable however the pores are evenly distributed compared to the result shown in figure 6. Another effect which can be seen is that the brittle phases are minimized as well.

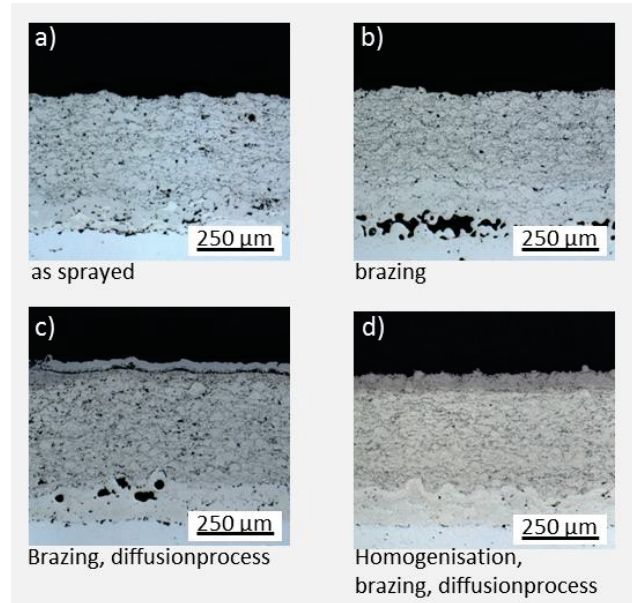
As mentioned in section 2 (Experimental) the HVOF process was taken into account and the results are essentially the same. Figure 10 summarizes the results of the HVOF coating system. Figure 10a shows the state as sprayed. Figure 10b depicts the heat-treatment of the coating after a brazing time of 90 minutes at brazing temperature, pores are formed in the brazing material. In figure 10c the coating was heat treated as shown in figure 6 (brazing and diffusion process). The brazing time was 15 minutes and the diffusion process below solidus had duration of 12 hours, locally pores can be observed. The enhanced heat-treatment due to figure 8 of the coating is shown in figure 10d. The homogenisation time was 24 hours, brazing time 15 minutes and the diffusion process 12 hours. The pores and the brittle-phases in the

brazed seam are minimized.

FIGURE 10. Brazing material/MCrAlY coating by means of HVOF
